Rio Grande in the Los Lunas Habitat Restoration Area

August, 2002

By: Tamara Massong and Dwight Slauch
River Analysis Team, Bureau of Reclamation, Albuquerque, NM
tmassong@uc.usbr.gov

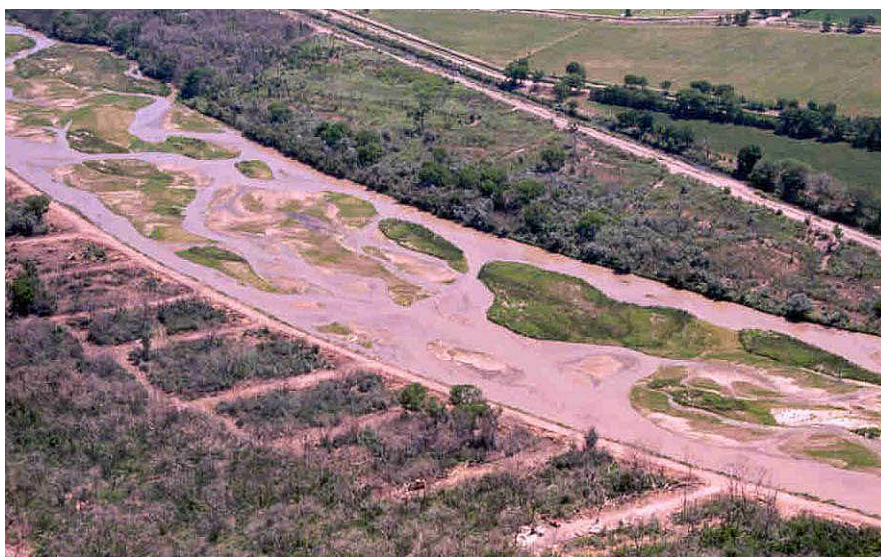
Figure 3: Aerial photograph of the Los Lunas Restoration Site and the adjoining Rio Grande, June 2002.

The Los Lunas project area is located at approximately river mile 157, on the west side of the river, and covers approximately 40 acres between the current channel bank and the west-side levee. The project is entirely contained within a burned area of the bosque; the fire occurred in the spring of 2000. The overall goal of the project, as presented in the Final Environmental Assessment (2002) is “to produce inundation of the project area at flows of greater than or equal to 2,500 cfs. For flows below 2,500 cfs, a variety of substrate elevations would be incorporated into the project design, which would allow for the inundation, to a lesser degree, of certain regions within the project area.”
